## How to recover the ISP Programmer

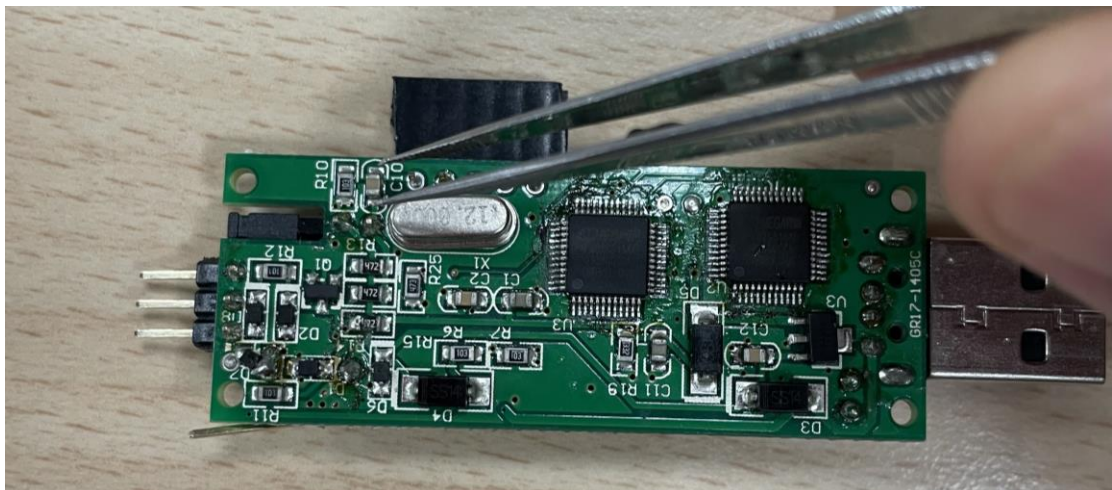
(ISP Programmer)

It is possible that ISP Programmer resides in the error state and not able to perform any further function. So, check your ISP Programmer when following conditions fit your situation:

1. No LED light when power on.
2. Has LED light at power on but UVCView.exe program does **not** detect the "ISP Programmer".

1. Remove the case of the ISP Programmer.
2. Connect the USB cable .
3. Short C10 capacitor a while (shown as the following).

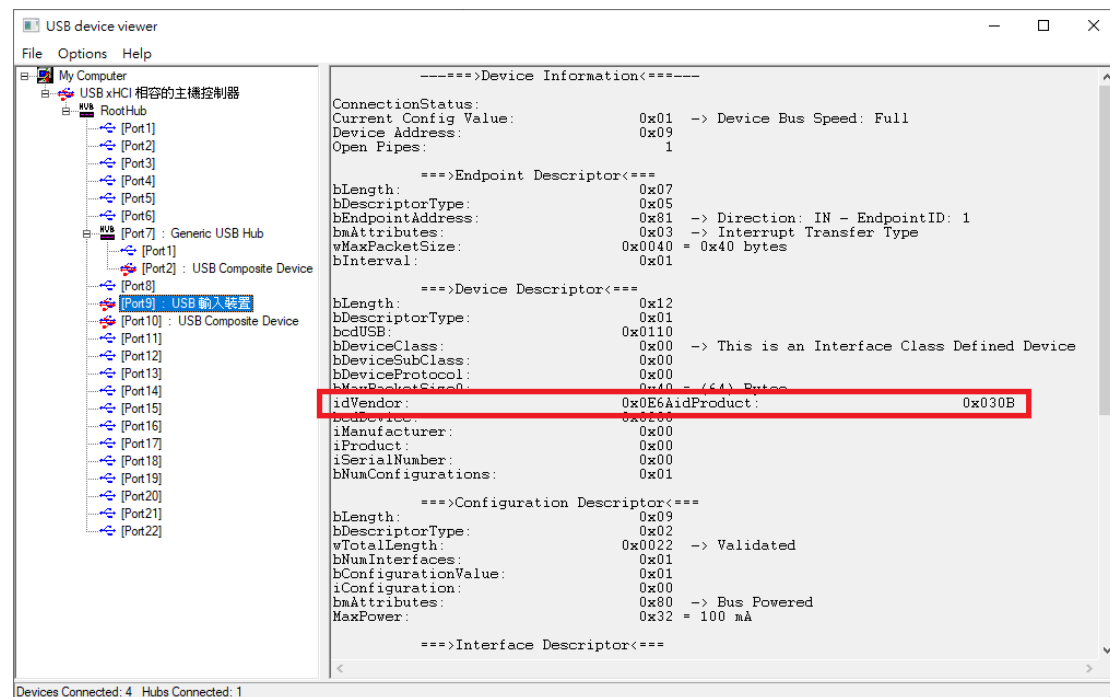
4. Check UVCView.exe to see if a device with VID: **0x0E6A** and PID: **0x030B** exist.

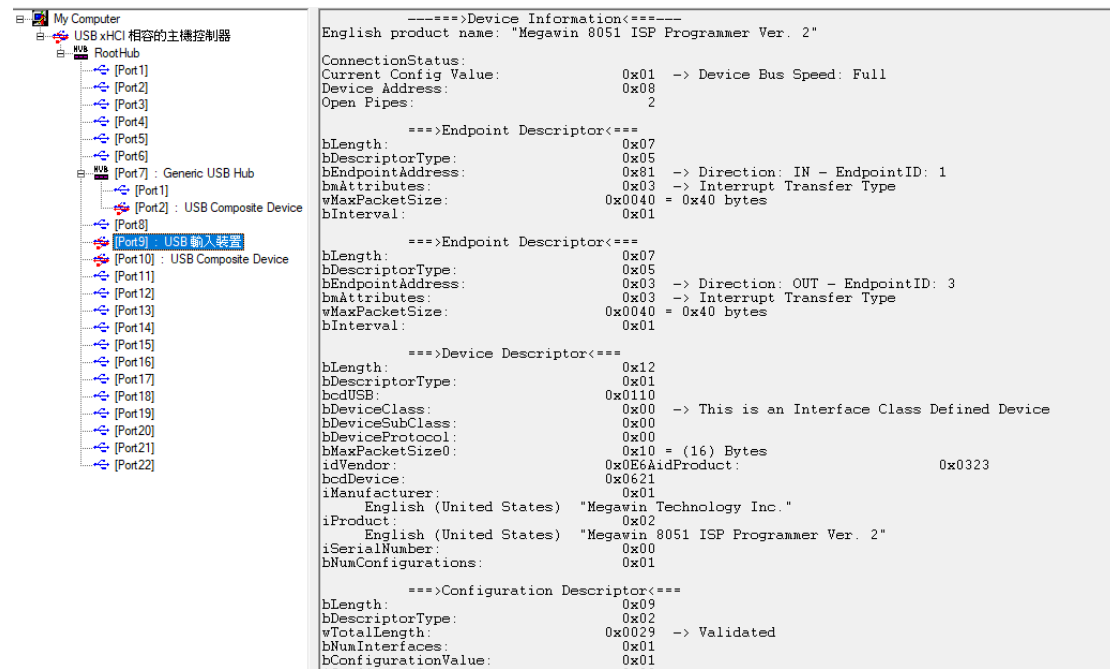
We should get a working “ISP Programmer” on the UVCView.exe.
